Cable checking - email@glasmacher-electronic.de

Measuring Head pi

Where is the cable problem? Where is the cable loose?

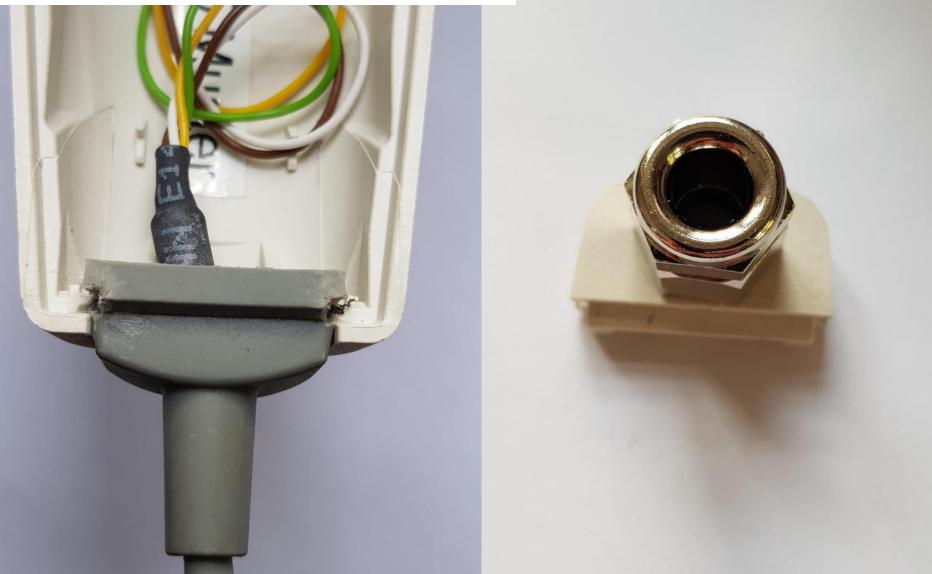
Because of repeated problems with the cable grommmet we changed it in early 2018 from glueing to clamping – please contact <u>email@glasmacher-electronic.de</u> so we can change for you in Germany or send you the metall clamp free of charge so you can change
